Subject: Beaver Valley Power Station (BVPS), Unit No. 2
BV-2 Docket No. 50-412, License No. NFP-73
NRC Bulletin 2004-01 Inspection 60-Day Report for 2R11

Evaluation Report for

Beaver Valley Unit 2

Pressurizer Penetration

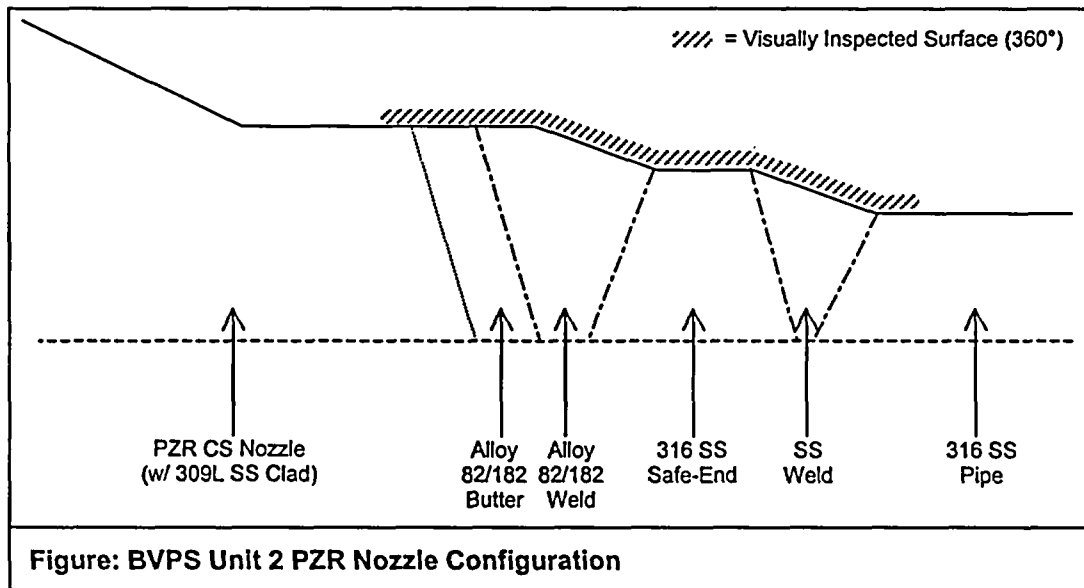
The five BVPS Unit 2 Alloy 82/182 pressurizer nozzle-to-safe-end welds are configured as shown in the Figure below. The safety (3) and relief (1) nozzle are 6" nozzles. The spray (1) nozzle is a 4" nozzle. All nozzle-to-safe-end welds are full penetration butt welds.
